Contract #: 04-0120F4Cty: SF/ALA Rte: 80 PM: 13.2/13.9File #: 69.28**WELDING INSPECTION REPORT****Resident Engineer:** Pursell, Gary**Address:** 333 Burma Road**City:** Oakland, CA 94607**Report No:** WIR-016278**Date Inspected:** 04-Aug-2010**Project Name:** SAS Superstructure**OSM Arrival Time:** 700**Prime Contractor:** American Bridge/Fluor Enterprises, a JV**OSM Departure Time:** 1900**Contractor:** Zhenhua Port Machinery Company, Ltd (ZPMC), Changxing Island **Location:** Shanghai, China**CWI Name:** Li Jia**CWI Present:** Yes No**Inspected CWI report:** Yes No N/A**Rod Oven in Use:** Yes No N/A**Electrode to specification:** Yes No N/A**Weld Procedures Followed:** Yes No N/A**Qualified Welders:** Yes No N/A**Verified Joint Fit-up:** Yes No N/A**Approved Drawings:** Yes No N/A**Approved WPS:** Yes No N/A**Delayed / Cancelled:** Yes No N/A**Bridge No:** 34-0006**Component:** OBG**Summary of Items Observed:**

BAY # 08, OBG BIKE PATH (NWIT # 06331)

WELDING INSPECTION REPORT

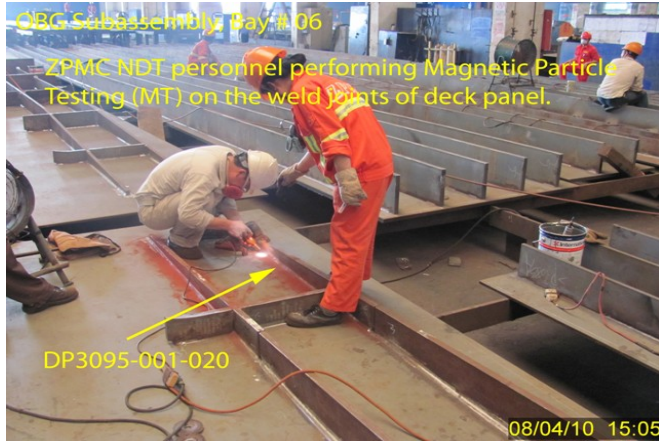
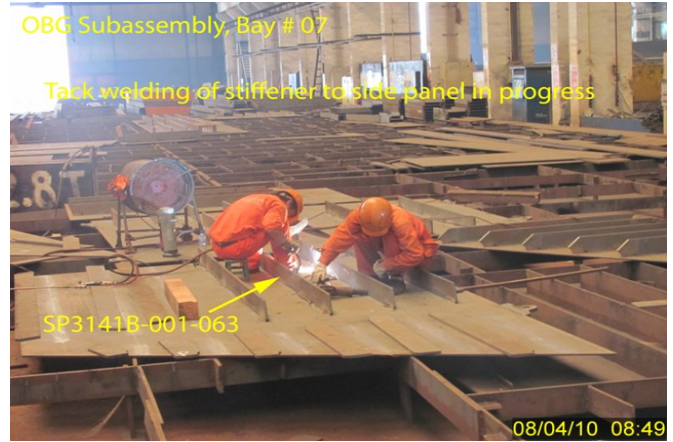
During random in process inspection this QA inspector observed that ZPMC NDT personnel was performing Magnetic Particle Testing (MT) on the fillet welds of OBG deck plate. The members are identified as OBG components and the weld designations reviewed are as follows.

SMAW tack welding of weld joint 63 located on SP3141B-001.
Welder is identified as 250833. ZPMC QC is identified as Mr. Wang Liang.
The welding variables recorded by QC appeared to comply with WPS-B-P-2112.
